Manhole Inspection Summary

Manhole # S21G__012MH

Location Address: **BEHIND 1721 FAYETTE ST**

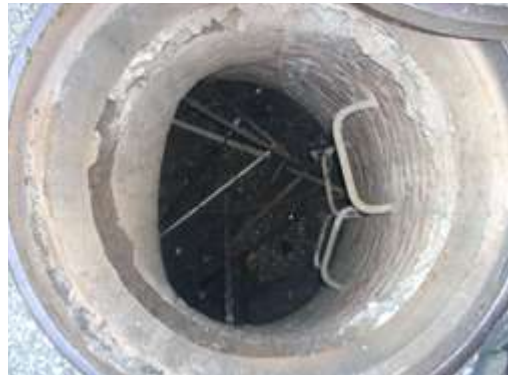
Top View

INFILTRATION OF CHIMNEY/ FRAME
OFFSET

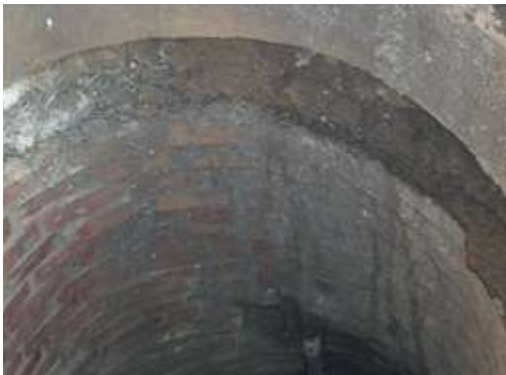
Defect 2

INFILTRATION OF CHIMNEY

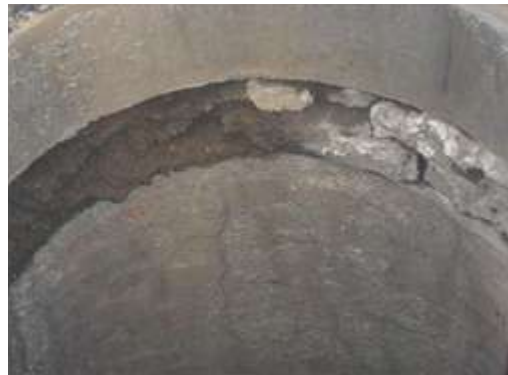
Defect 1

DETERIORATION OF CHIMNEY

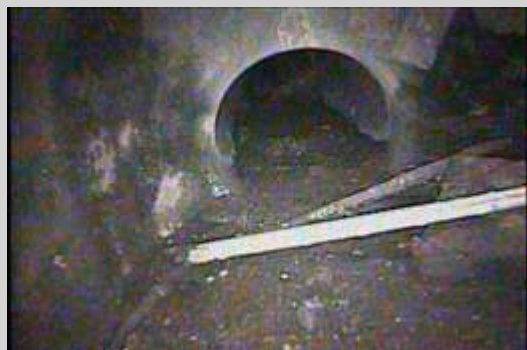
12 O'Clock Outflow

8 in. Circular Gravity Sewer
Pipe Out @ 12 O'Clock

Deposits: ☐ None ☐ Mud ☐ Sludge ☒ **Debris** ☐ Grease

Silt Depth: **1** (in.) Deposits Extent: **Medium**
